Astor (brand), Radio Corporation Pty., Ltd.;  
Melbourne

Year 1949

## Restoration Summary:

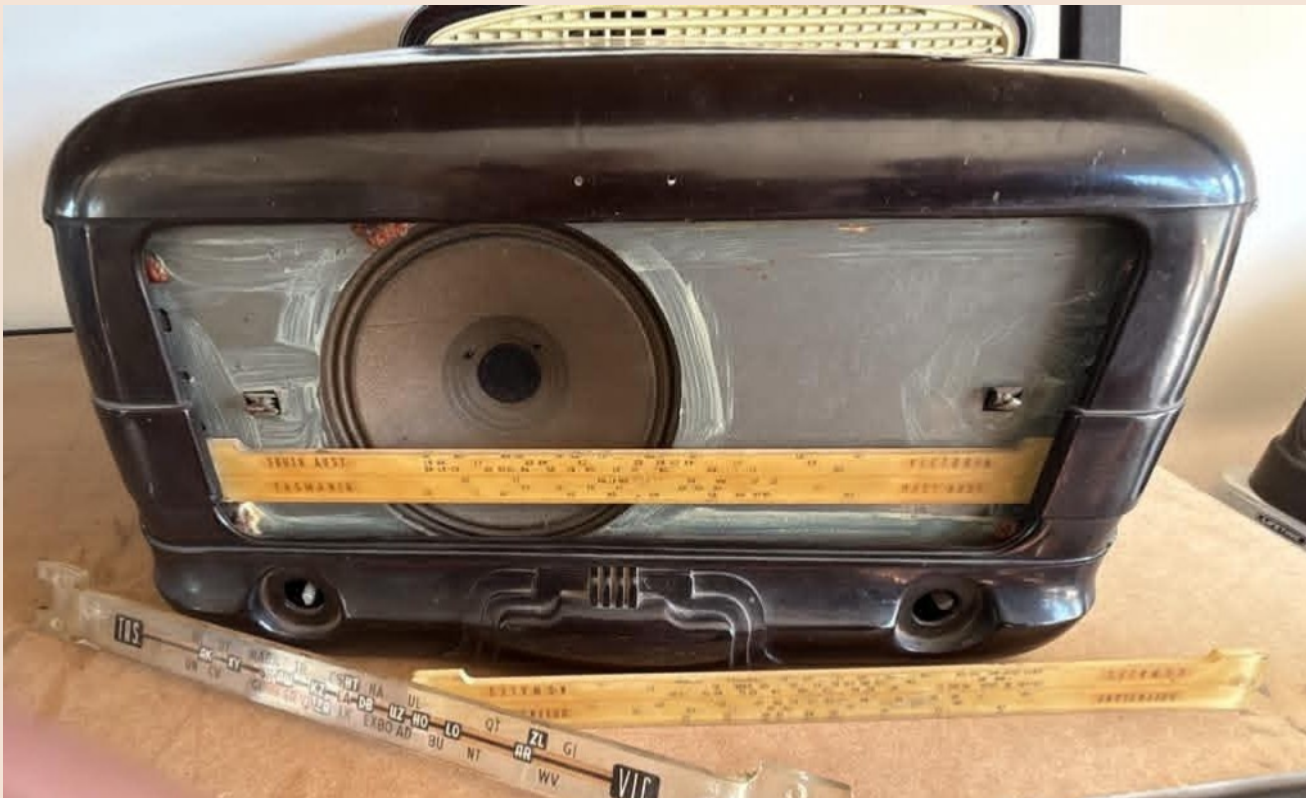
Fig 1. Original very early model Astor GJ built 1949 Serial No. 281.

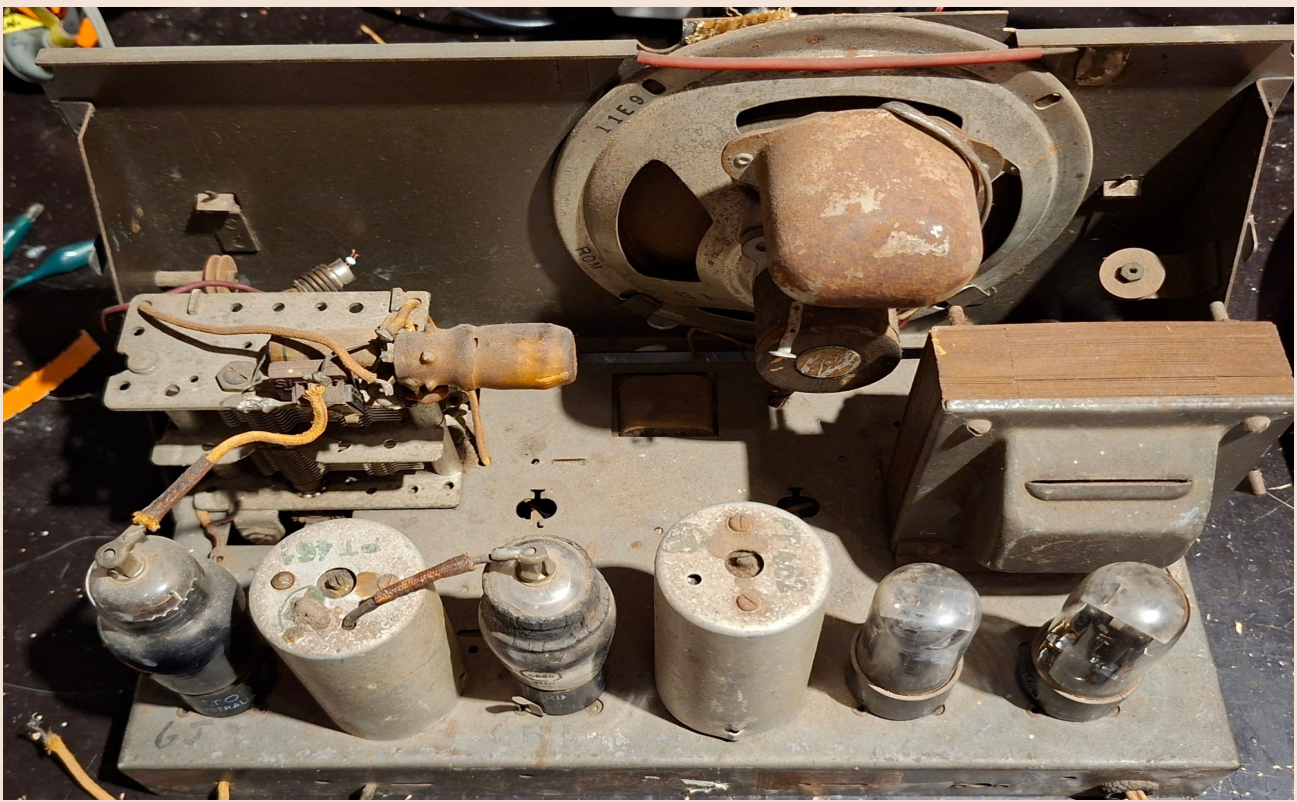
Fig 2. Chassis as found

Radio passed all safety checks and was slowly powered up without and with Valves. Voltage checks, found 5Y3 valve with very low emissions causing B+ incorrect voltage. No reception but Audio was working. Most Capacitors were replaced starting with 16uF electrolytics which were stuffed into original housings and a number of resistors were replaced with period resistors within the desired spec. Alignment was completed following factory procedure. Radio was now working well, though original power switch on volume control was not consistently working.

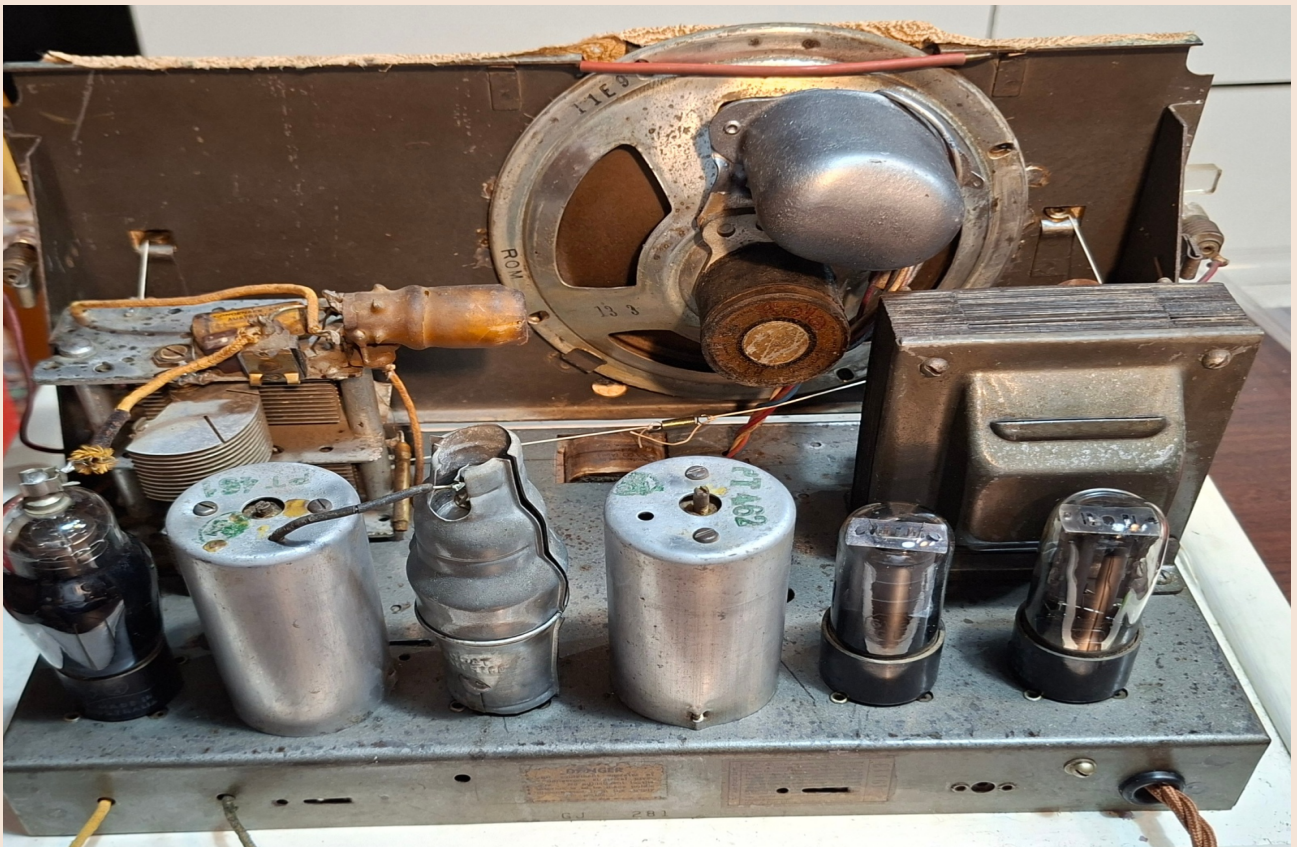
Fig 3. After Chassis Restoration

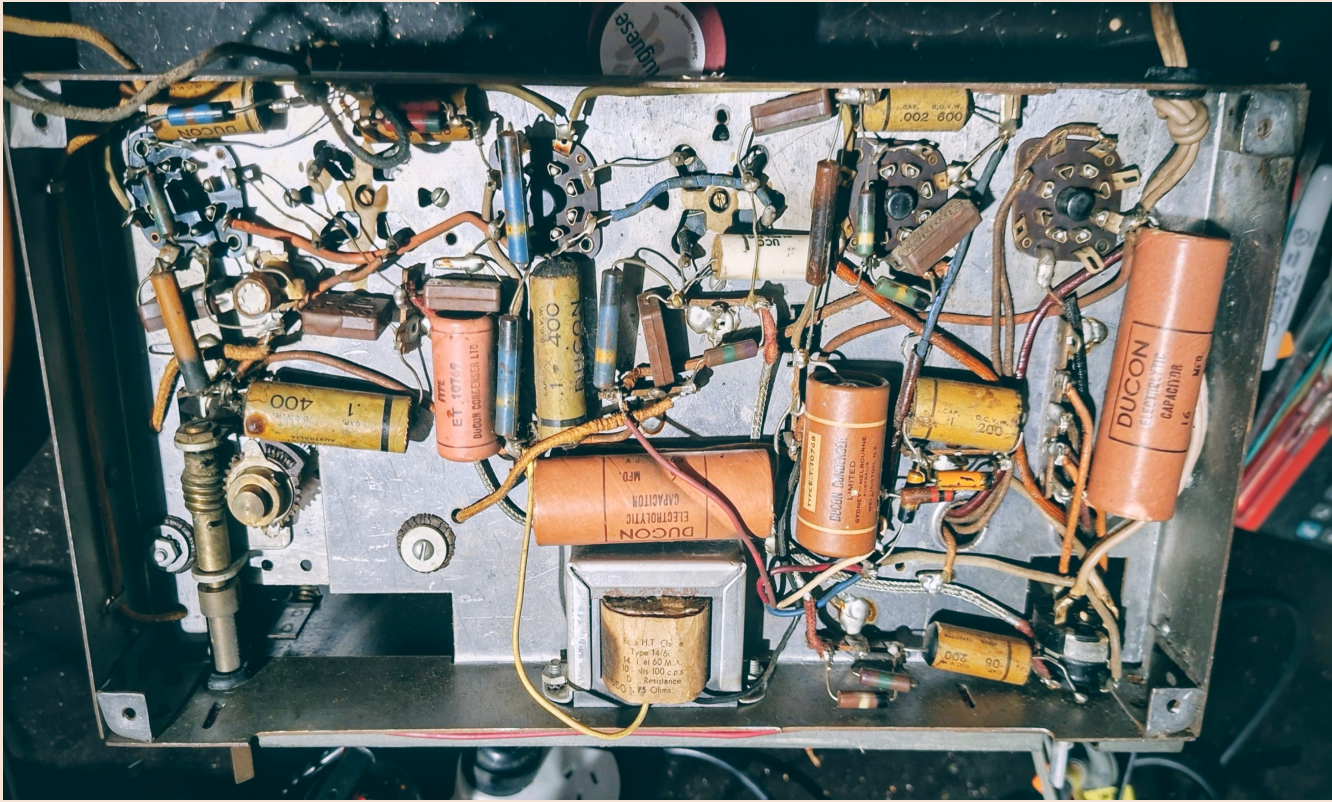
Fig 4. Parts and factory layout before any repair work.

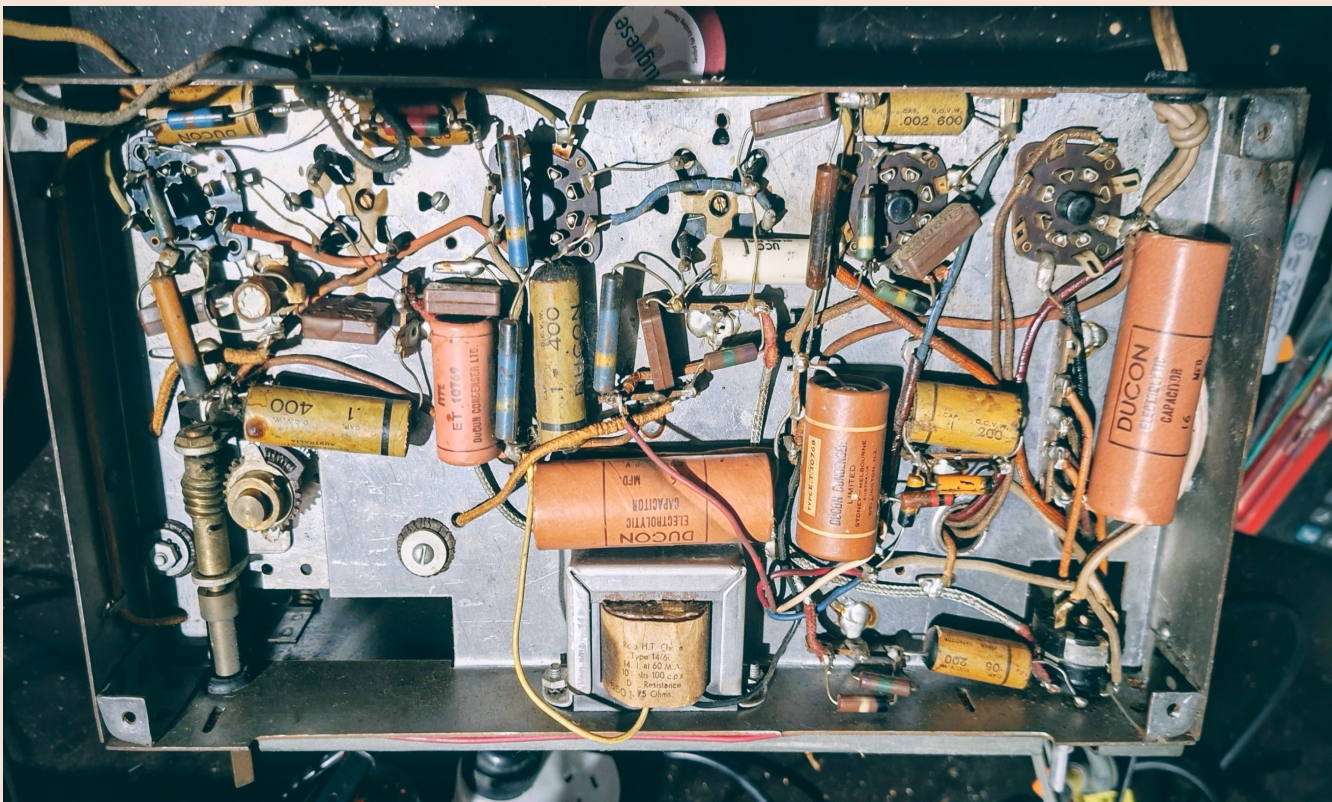
Fig 5. After full service and replacement parts into original housing and layout.

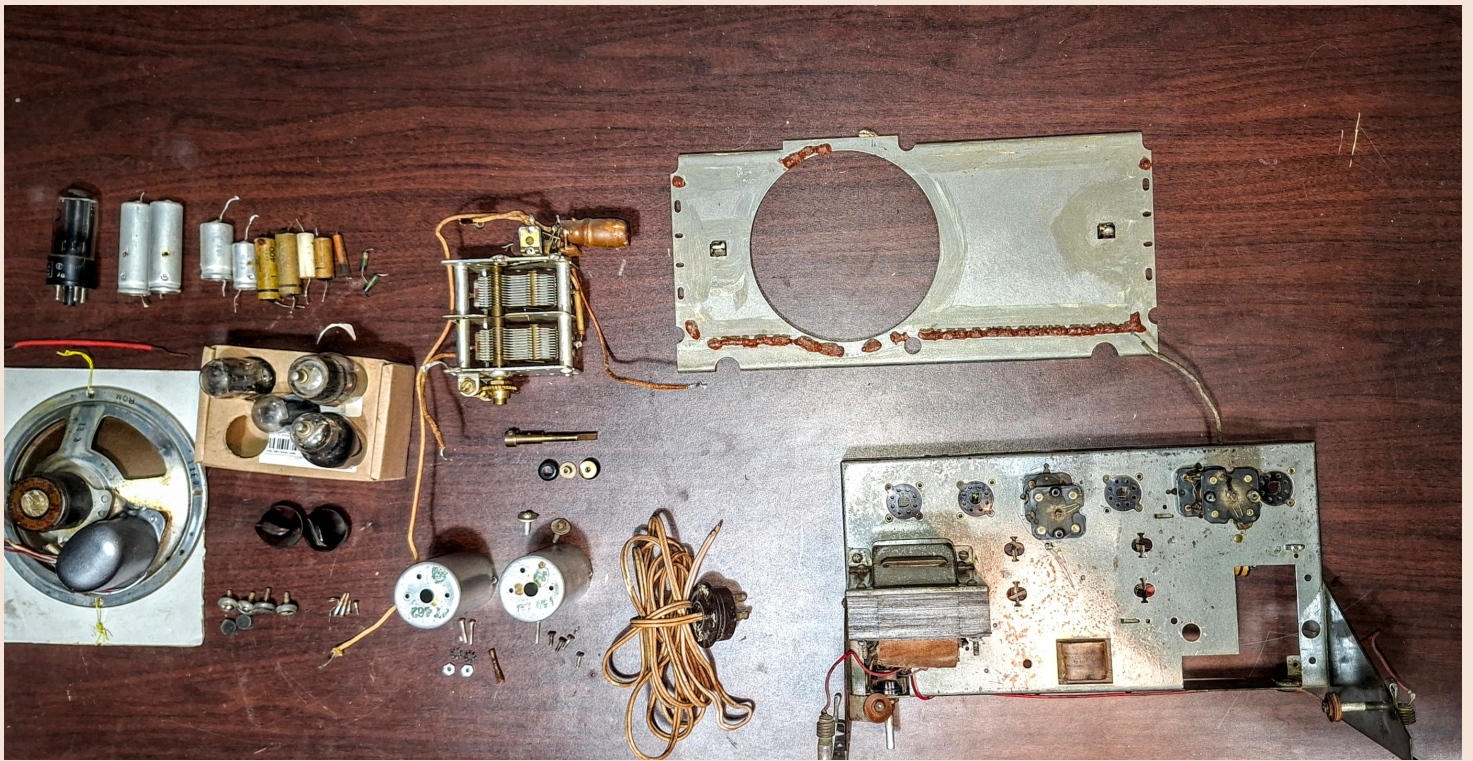
Fig 6 Break down of key components allowing for cleaning.

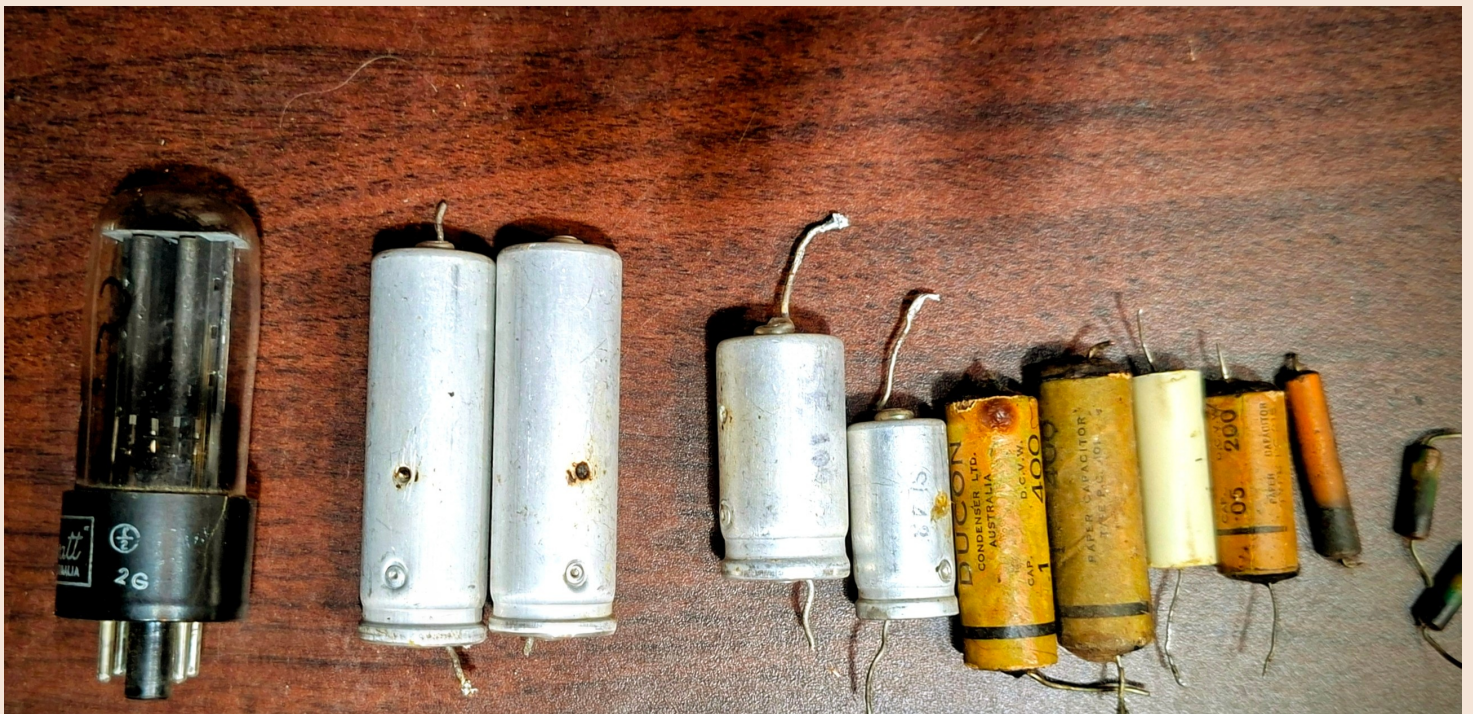
Fig 7 Parts after 77 years that had failed.

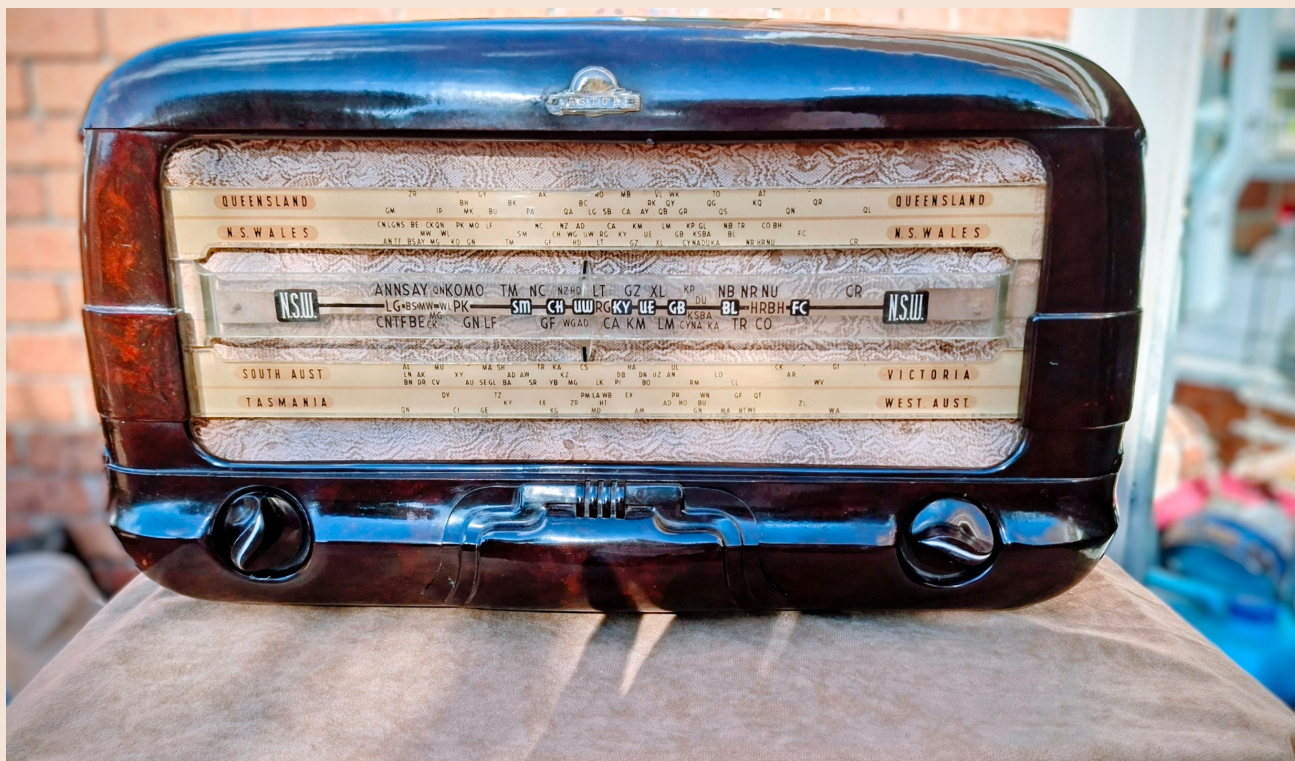
Fig 8 Completed Radio ready for display and operation.

Cabinet had all paints spots were removed and was cleaned and polished with Brasso then a bees wax protective polish was applied.

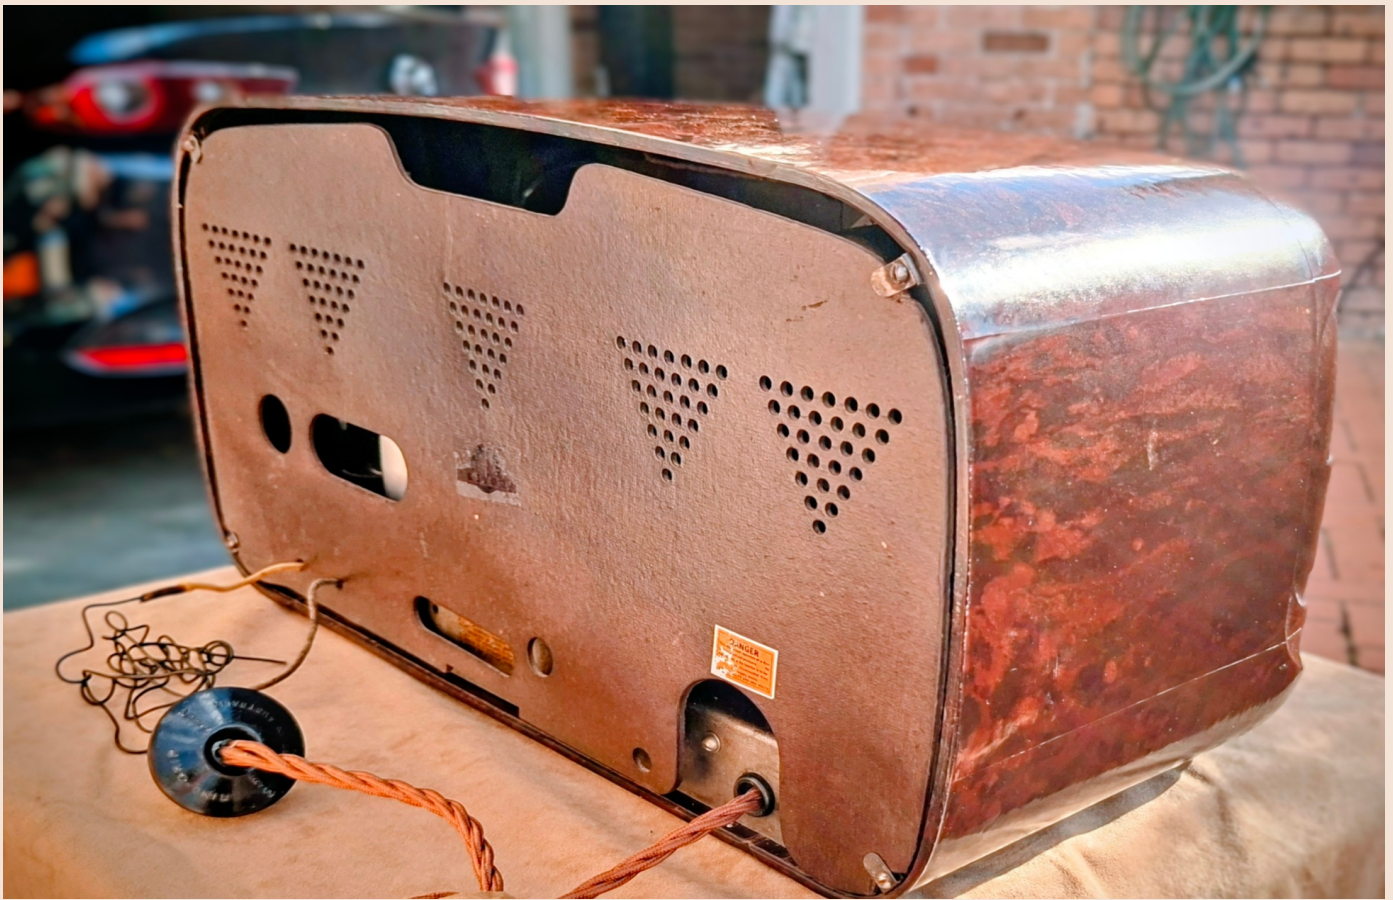
Fig 9 Original Back Panel.
